Experimental Study ND 98-06

**Fabric Reinforced Backfill
Under Approach Slabs**

Final Report

PROJECT NH-4-002(051)138

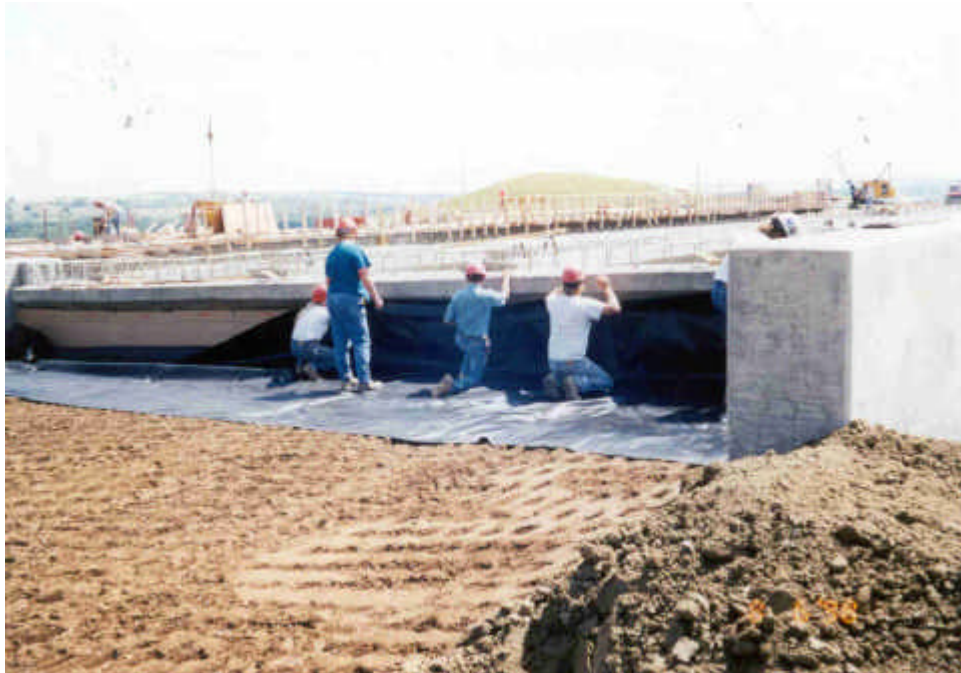
Photo 1 – Tacking R1 fabric before placement of the next one foot of select fill.

Geotextile fabrics were used to wrap the drainage system and in the select backfill. A D2 type filter fabric was used to wrap the 4" drainage system. R1 reinforcement fabric was used to wrap each 1' lift of select backfill until the required height was reached.

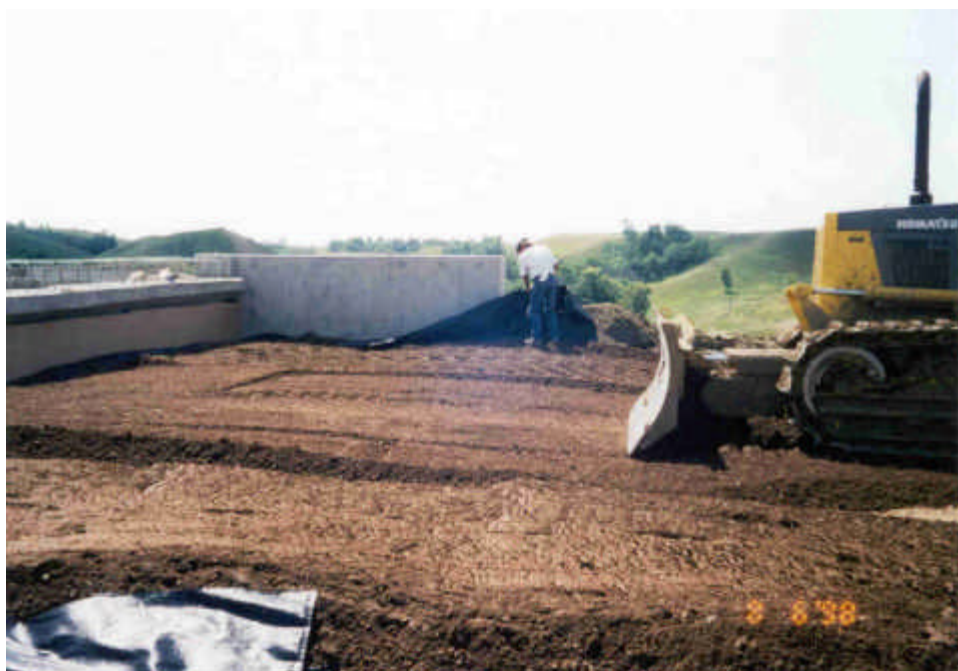
Photo 2 – Select fill placed over fabric wrap.

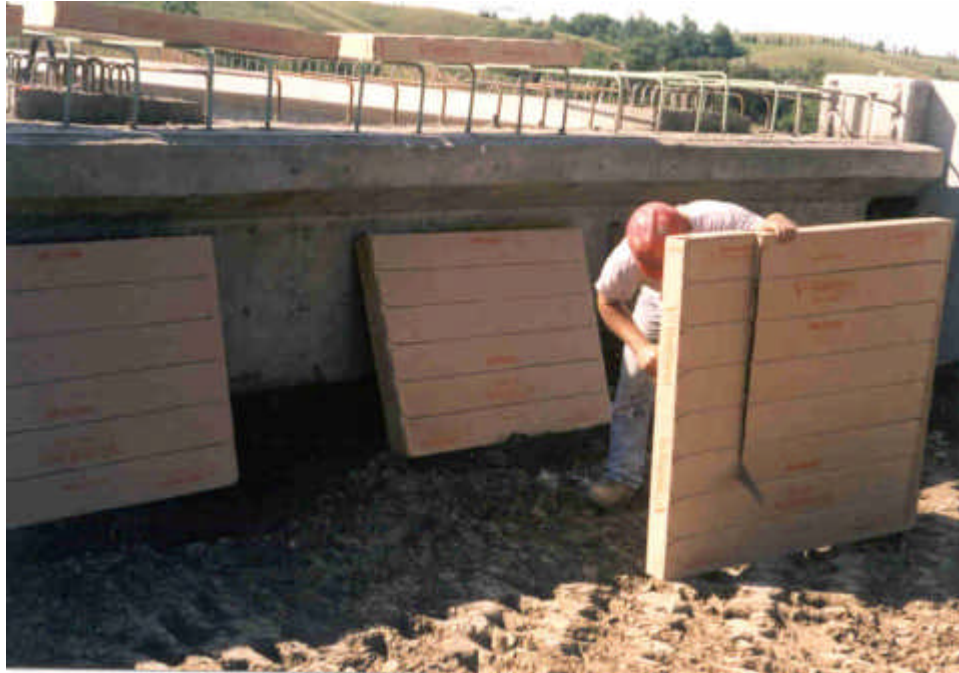
Photo 3 – Cutting void form for installation against abutment wall.

A class 5 material was tested and met the requirement for select fill. The test worksheet is located in Appendix B. The 3" void material was not available in such small quantities and an alternate 4" void form was used.

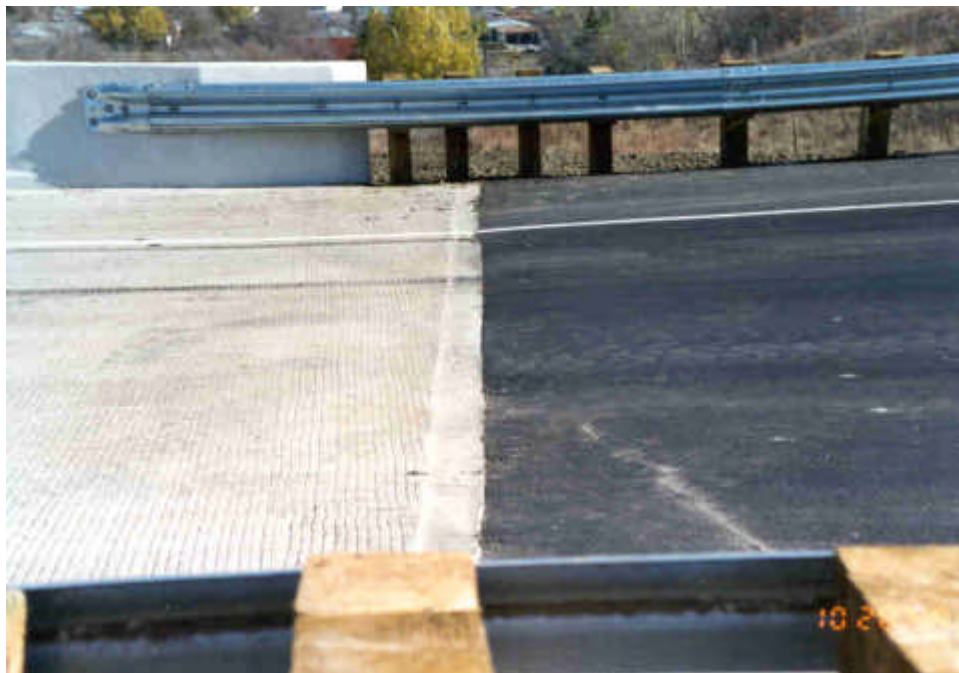
Photo 4 – Asphalt meets approach slab of the control section.

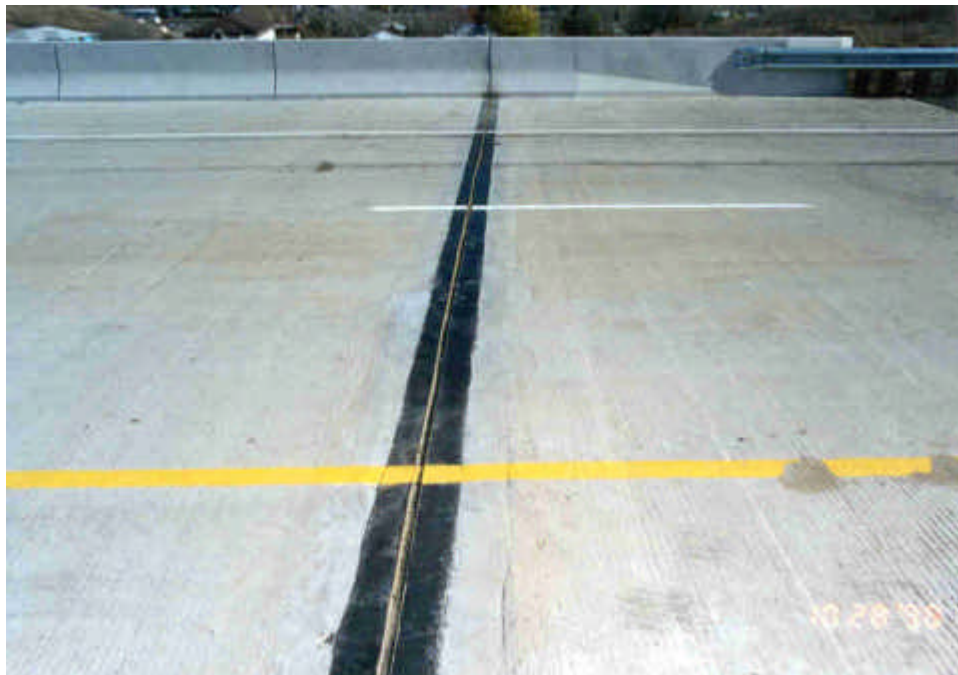
The approach slab was formed and poured over the experimental section at the same time as the bridge deck. The approach slab is 14" thick. Appendix B contains the concrete proportion design and compression test of a concrete cylinder for the approach slab. The roadway was paved with asphalt up to the approach slab. Photos were taken after the project was completed. Photos 4 and 5 show the approach slab of abutment 4-westbound bridge (control section). Photo 5 shows that the slab is in good condition and that the joint looks good.

Photo 5 – Approach slab meets bridge in the control section – Westbound Bridge.

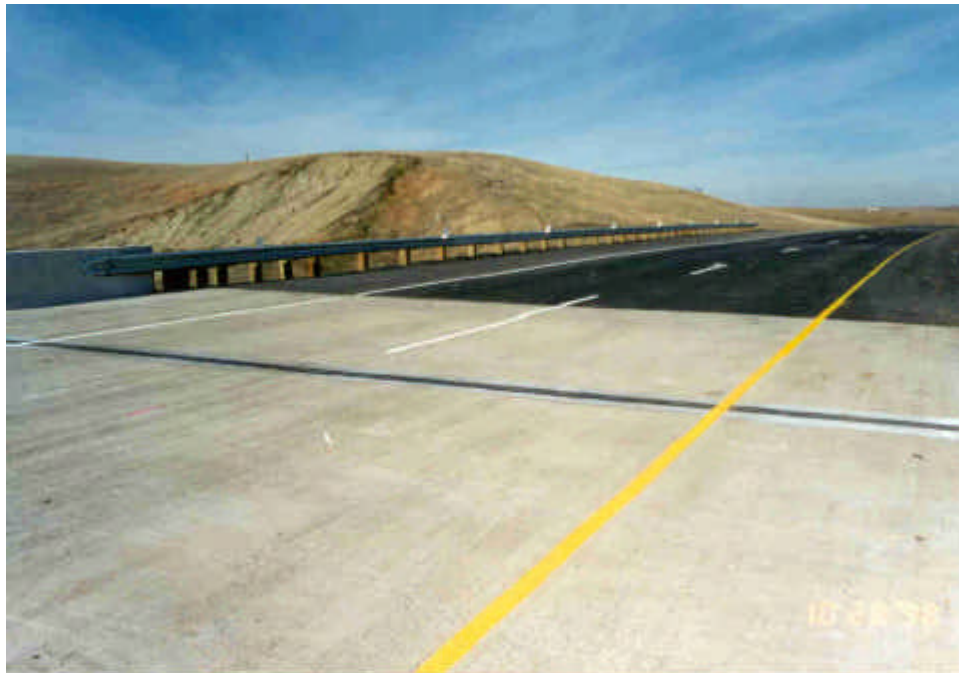
Photo 6 shows a view looking west at the experimental approach slab of the eastbound bridge of the Burlington bridges. These bridges have been open to traffic for about one day. Photo 7 shows the beginning of the approach slab and surface tining. A slight dip was noticed where the asphalt meets the concrete, but appears not to affect the ride as observed from the side of the road.

Photo 6 - Overview of experimental approach slab – Abutment 1 Eastbound Bridge.

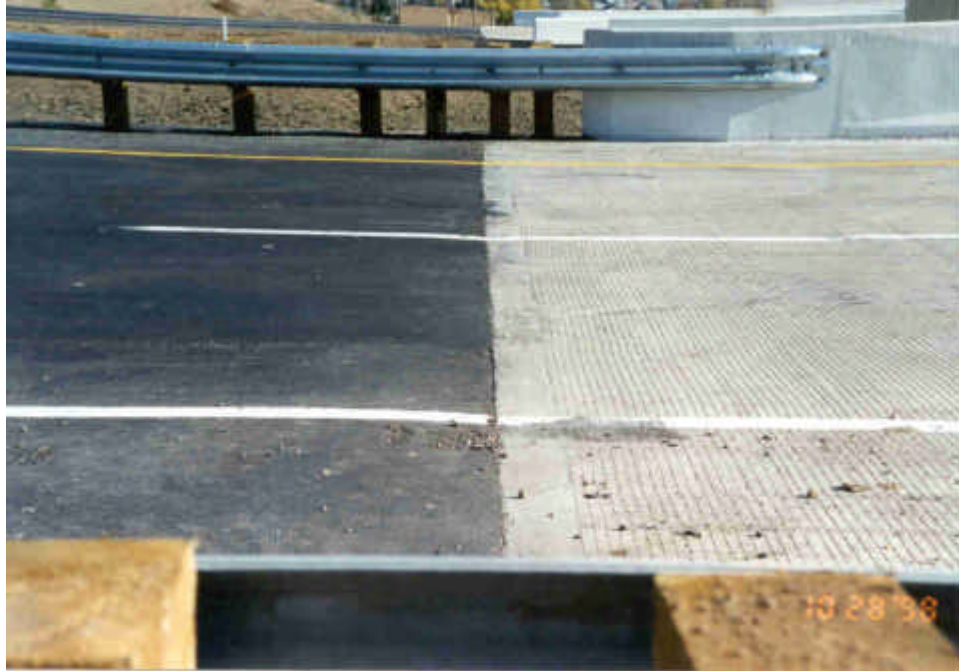
Photo 7 – Asphalt meets approach slab of the experimental section.

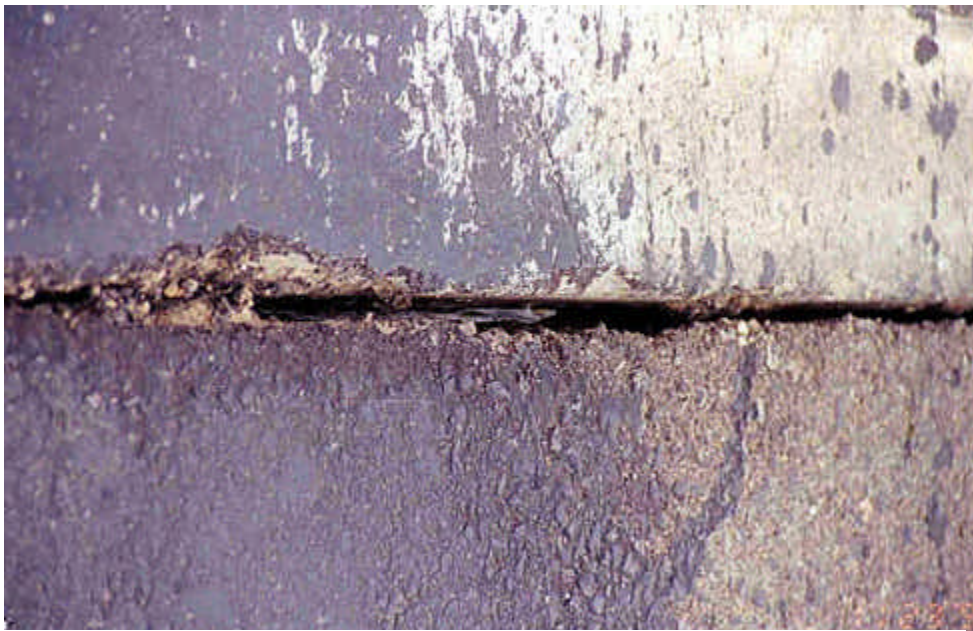
During the summer of 2000, a contract project to mill bumps at bridges included this experimental section. The milling improved the general overall ride but did not completely remove the bump. Photo 9 shows that in the cold winter months a 1 inch gap opens up between the asphalt and approach slabs. A tape measure can be inserted to a depth ranging from 6 to 12 inches.

Photo 9 – Winter 1999 gap opening of 1 inch between asphalt and approach slab in the Control Section WB.

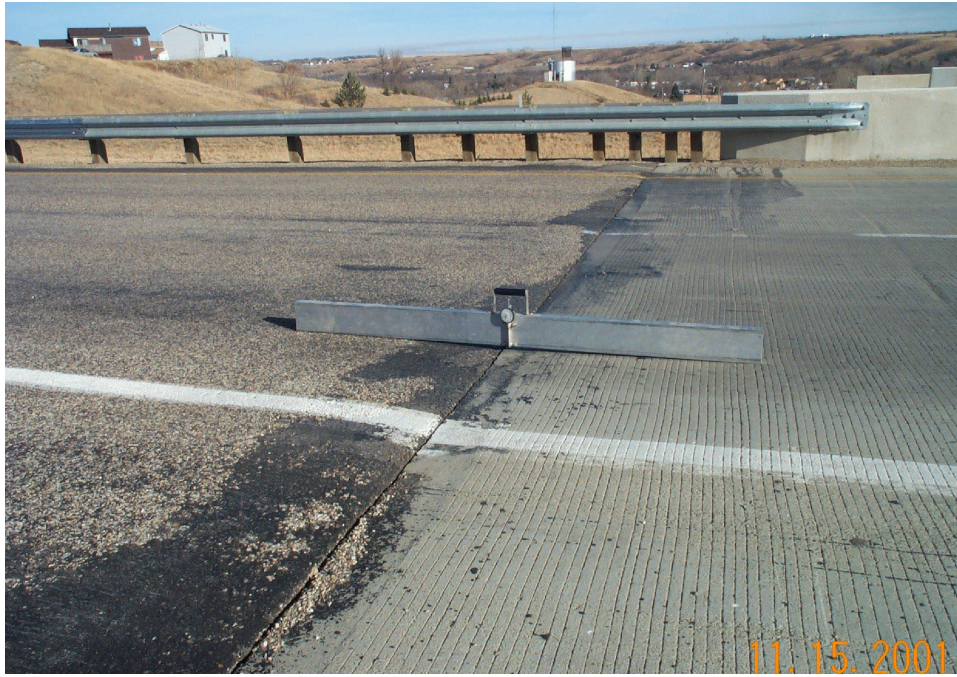
This bump in the eastbound experimental section where the asphalt meets the approach slab has been getting worse each year. Photo's 12 and 13 were taken in November of 2001. The approach slab receives a dynamic load each time a loaded truck hits it at highway speeds. This puts a lot of stress on the approach slab.

Photo 12 – Shows drop from asphalt to approach slab in the outside wheelpath of the experimental section of approximately $\frac{3}{4}$ inch.

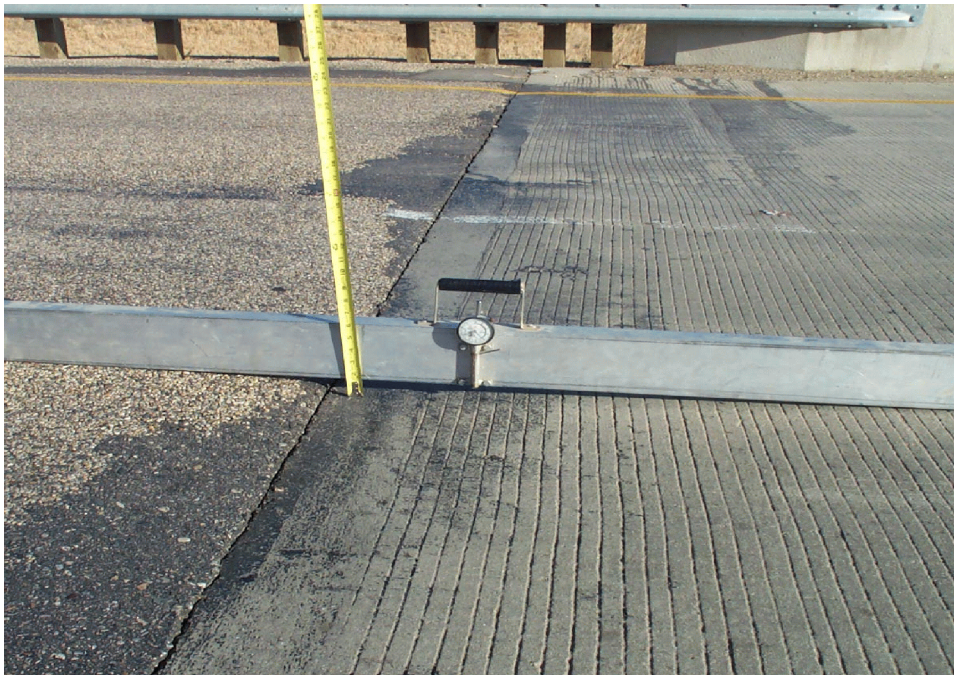
Photo 13 – Between wheel paths of driving lane – 1 $\frac{1}{2}$ " drop from asphalt to approach slab.

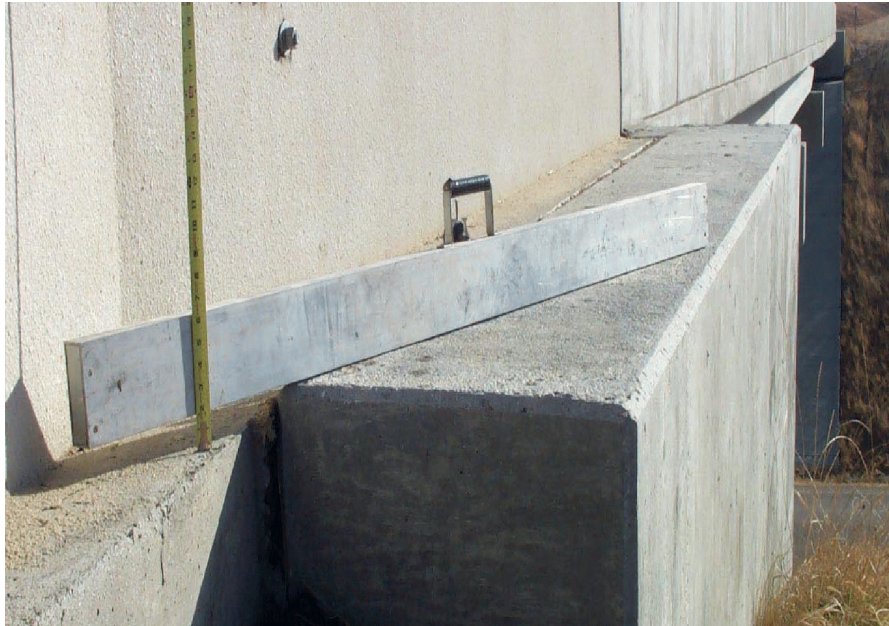
The approach slabs are settling as shown in photos 14 and 15. This measurement is taken at the end of the wing wall which is 14 feet from the abutment wall or 4 feet from the beginning of the approach slab.

**Photo 14 – 1 3/8” drop from wingwall to approach slab.
Experimental section Rt.**

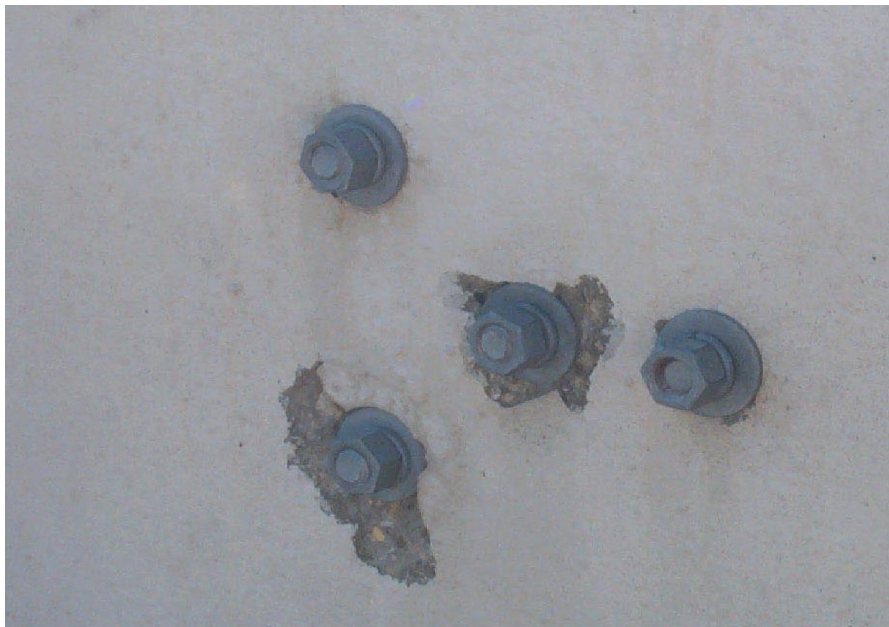
**Photo 15 – Experimental section Lt. Side – or Passing lane
side, the guard rail bolts show stressing at the wingwall due
to settling of the approach slab.**
